Residential Inspection Report

**6622 Stellar Place
Haymarket, VA 20169**

Prepared By: **Brian Henley**
ASHI Associate Home Inspector

11/18/2009

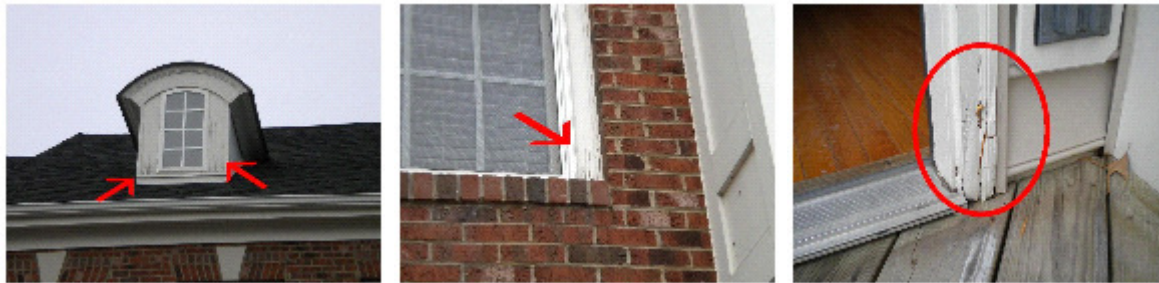
EAVES & TRIM TYPE:	TYPE: Wood.
EAVES & TRIM CONDITION 1:	OBSERVATIONS: Rot present in trim in places-Both dormers, front windows, door to deck, misc other areas-Needs Repair.

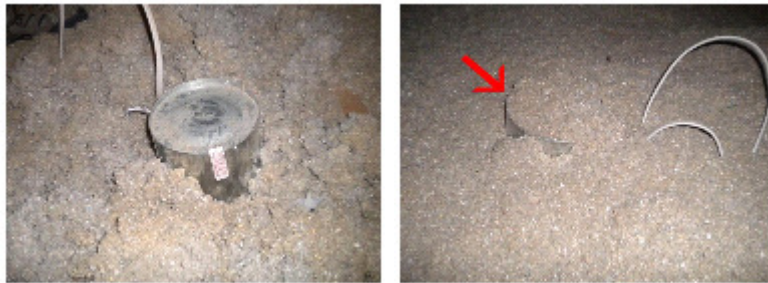
Electrical Recessed lighting fixtures are **NOT** IC rated and lights are buried with insulation. Pull back insulation at least 3 inches from around all fixtures as stated on each housing.

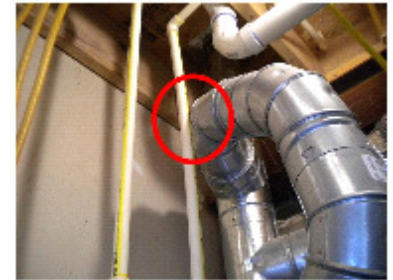
Flue/Exhaust Pipe Condition:

Attention Needed - The flue piping needs some minor attention or adjustment. Close proximity to plastic water line. Reconfigure flue piping for proper clearance from plastic water pipe.

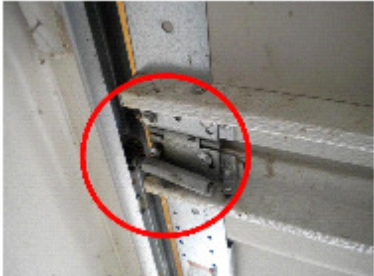
Garage Type	The garage is attached.
Size of Garage:	Two car garage.
Number of Overhead Doors	There is a single overhead door. The overhead doors are made of a synthetic plastic or fiberglass. The garage door is insulated. This is an energy saving benefit.
Overhead Door and Hardware Condition:	<p style="color: green;">Attention Needed - The overhead door needs some minor repair. Some parts of the door hardware need to be adjusted or tightened.</p>

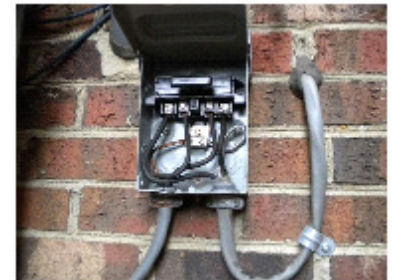
Service Disconnect: Attention - No internal cover. This could allow someone to touch live electrical circuits if the exterior cover is lifted.

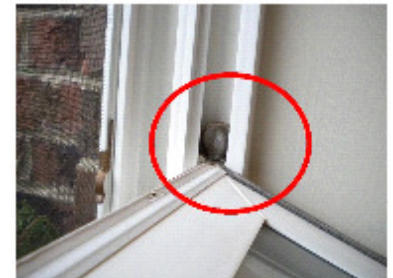
Front Entry Door: Satisfactory - The main entry door to the structure is in functional condition.
Entry Floor: The floor covering material is wood.
Main Hallway: Satisfactory - The main hallway walls and floor are in satisfactory condition.
Smoke Detector: Removed from ceiling.
Coat Closet: Satisfactory - The guest closet is functional and of average size.
Windows: Action Necessary - At least one window or associated hardware in this room needs repair. The spring or slide that holds the window in the up position is not functional. It needs to be replaced.

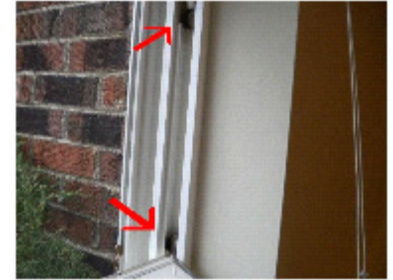
Windows: Action Necessary - At least one window or associated hardware in this room needs repair. The spring or slide that holds the window in the up position is not functional. It needs to be replaced. Front corner.

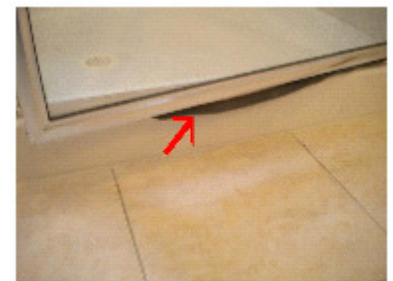
- Tub/Shower Drain:** Satisfactory - The tub/shower appears to drain at an acceptable rate.
- Glass Tub/Shower Door:** Yes, Safety Glass? - There is a set of sliding glass doors installed. I was not able to determine if they are made of safety glass. Door gasket at the bottom has fallen loose and needs to be reattached.

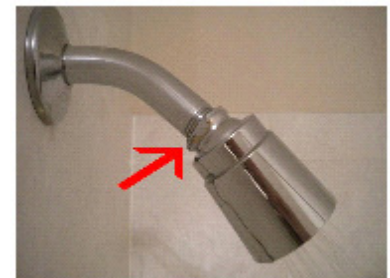
Shower Head and Mixing Valves: Attention - The shower head leaks and needs adjustment or replacement.

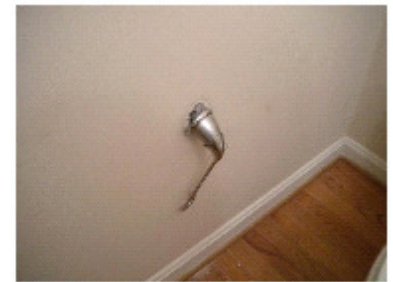
Good w/minor issue:

The entry door and window (if applicable) are operating with normal access. The toilet is tight to the floor and flushes normally after multiple attempts. The sink, fixtures, drains and cabinetry are in good shape. The surrounding floors appear to be in normal condition with no apparent caulking necessary other than normal maintenance. Continue to monitor all functions of the bathrooms to prevent unwanted repairs. The toilet paper holder is broken and is hanging from the wall.

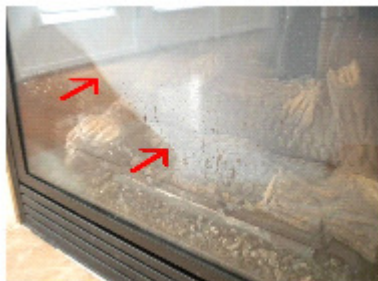
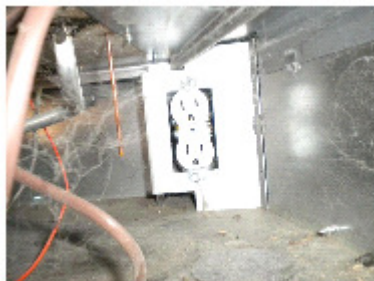
Location of Fireplace:	Bump out area.
Type of Fireplace:	Zero Clearance - There is a zero clearance fireplace installed. It is a metal double or triple walled unit that allows installation within inches of flammable materials rather than the standard 36 inch clearance on standard free standing metal fireplaces.
Fireplace Fuel:	Gas - The fireplace is designed to use gas fuel only.
Source of Combustion Air:	Outside air is used for combustion. This is the most efficient system.
Hearth Condition:	The hearth is in satisfactory condition.
Comment:	Fireplace glass is dirty from condensate and needs to be removed and cleaned. Electrical box behind louvered access door is missing its cover.

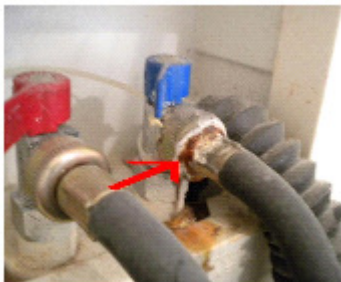
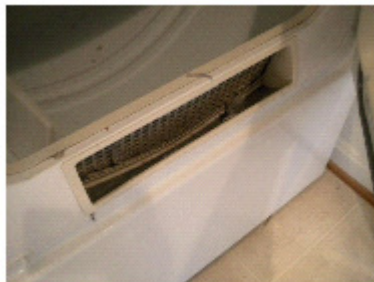
Corroded hose on washer hookup should be replaced. Recommend using steel braided hoses.

Dryer Hookup:	Yes - There is a 240-volt outlet provided for an electric dryer. If you intend to use a gas clothes dryer, you will need to have a gas line installed.
Dryer Ventilation:	Satisfactory - The dryer ventilation as installed appears adequate. The vent hood outside is clean, and the flapper is functional.
Area Ventilation:	Satisfactory - The area ventilation seems adequate.
Comments:	Corroded hose on washer hookup should be replaced. Recommend using steel braided hoses. Dryer vent and vent piping should be cleaned. Dryer unit is missing its removable lint screen.
